ADVANCED LIFE ANALYSIS **METHODS - Cracking Data** Survey and NDI Assessment for Attachment Lugs

September 1984

Final Report for Period 3 September 1980 to 30 September 1984

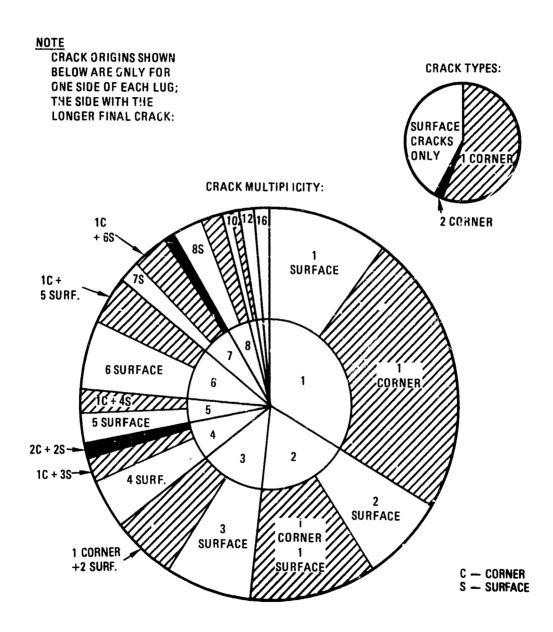
Figure 3-3. Number of Origins of Primary Crack, 155 Lug Coupons (Kiddle [1])

Examining the crack surfaces after testing, Kiddle finds a strong trend toward increasing number of flaw origins with increasing applied stress. The large pie chart in Figure 3-3 shows the number and type of crack origins that occurred on the "primary" crack side of the lug hole, the side with the larger final crack. Multiple crack origins occurred in more than two-thirds of the 155 specimens, with as many as 16 separate origins found across the 0.3-inch thickness. As the small pie chart shows, more than half the specimens had at least one corner crack origin. Data are very similar for the secondary (shorter) crack in Kiddle's lugs, Figure 3-4. It is noteworthy that all but two of the 155 specimens generated fatigue cracks on both sides of the lug hole during fatigue testing.

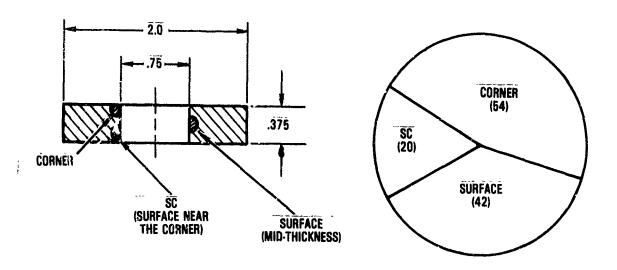
Figure 3-5. Crack Types for Dominant Fatigue Cracks (Ghena [3])

Constant amplitude fatigue test results on lugs similar in geometry to those of Kiddle [1] are reported by Ghena [3]. Although multiple crack origins occurred and were mentioned, they were not systematically reported. However, the crack types (corner, mid-thickness surface, or near-corner surface cracks) in the bore of the hole were recorded for the dominant fatigue cracks leading eventually to failure in the 58 specimens. As Figure 3-5 shows, corner cracks and surface cracks were about equally common in these tests. The pins were close-tolerance clearance fit, as in [1].

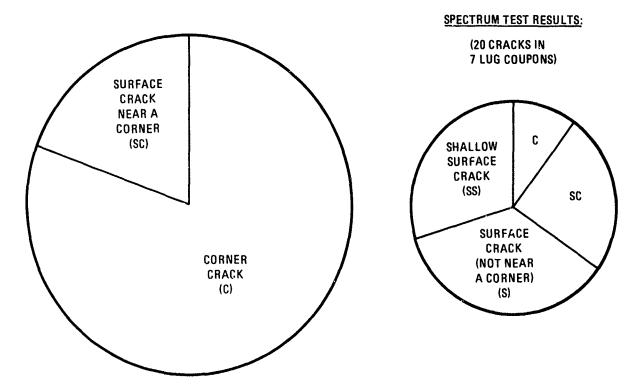
Figure 3-6. Crack Types in Thick Aluminum Lugs Under Constant Amplitude or Spectrum Fatigue Loading (Mann, et. al. [4])

Multiple corner cracking dominated the behavior in the 16 constant amplitude tests. Four specimens were tested at each of four stress levels. Each specimen had a lug hole at either end, so when one end failed, the other end had cracking present also. After residual strength tests of the unbroken ends, 32 fracture surfaces could be examined for fatigue cracks. The four classes of cracks observed are sketched in Figure 3-6. These are corner cracks (C); semicircular surface cracks with the crack centerline within 0.1 inch of the corner (SC); semicircular surface cracks within the hole bore (S); and shallow surface cracks (SS). As the large pie chart shows, 71 cracks were corner cracks and 17 were near-corner cracks. There were no type-S or type-SS cracks produced by constant amplitude loading.

The four spectrum tests involved a low-high-low sequence of the same stress levels as used in the constant-amplitude testing. As sketched in Figure 3-6, the largest stress level occurred only once per block.

The spectrum test results are shown in the smaller pie chart in Figure 3-6. In contrast to the cracks in the constant amplitude test specimens, only 2 were corner (C) and 5 were near-corner (SC) cracks, out of 20 total cracks. Furthermore, the spectrum fatigue lives were much longer than would have been predicted by linear cumulative damage analysis using the constant amplitude test results.

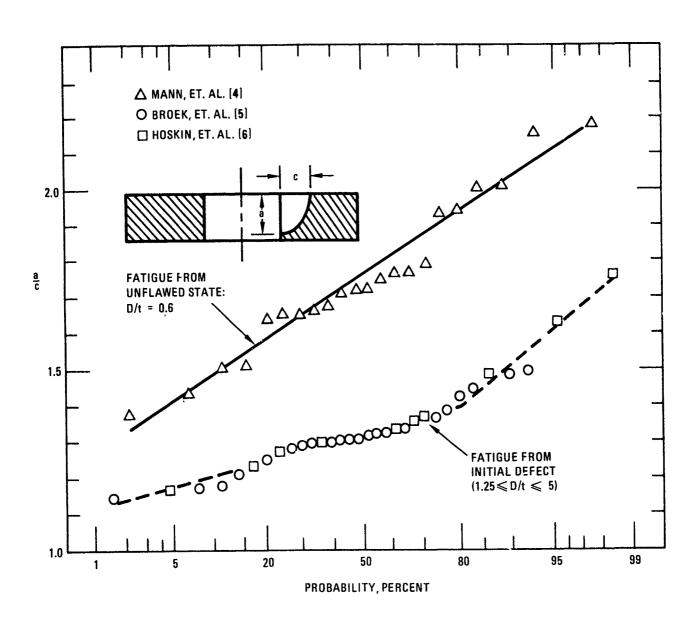
Figure 3-7. Corner Crack Shape in Lugs

For cases in which corner cracks occur, guidelines are needed for estimating corner flaw shape. Figure 3-7 shows a probability plot for the 22 cracks larger than 0.1-inch deep along the hole wall in the residual-strength tested lug ends of Mann, et al. [4]. The crack depth-to-length ratios (a/c) range between 1.38 and 2.18, with an average of 1.76. Shallower fatigue-induced corner crack shapes were observed by Broek, et al. [5] in data covering two aluminum alloys and three lug thicknesses ranging from D/t = 1.25 to 5. These data are also plotted in Figure 3-7. The a/c ratios range from 1.13 to 1.49, with a mean of 1.32. Their results are confirmed by ten data points presented by Hoskin and Carey [6] for 7079-T6 Aluminum lugs with a D/t ratio of 2.65, for which the a/c ratio ranged from 1.15 to 1.76 with a mean of 1.38.

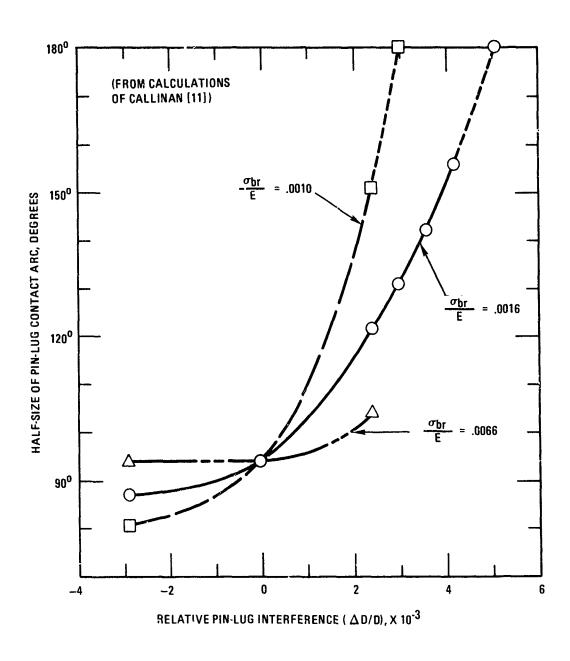
Figure 3-9. Dependence of Pin-Lug Contact Arc on Pin Fit

Lug pin pressure distributions were calculated by Callinan [11] using finite element analysis for various pin clearances and interferences. The results confirm the shift in the critical fretting point with pin fit, but also show a dependence on load magnitude. Figure 3-9 shows that for a bearing stress ratio of 0.0016 (corresponding to  $\sigma_{\rm br}$  = 16 ksi in an aluminum lug), the edge of the estimated pin contact arc shifts from 87 degrees for 0.3 percent clearance fit to 156 degrees for 0.4 percent interference. Note in Figure 3-10, however, that the arc of contact for either clearance or interference-fit pins

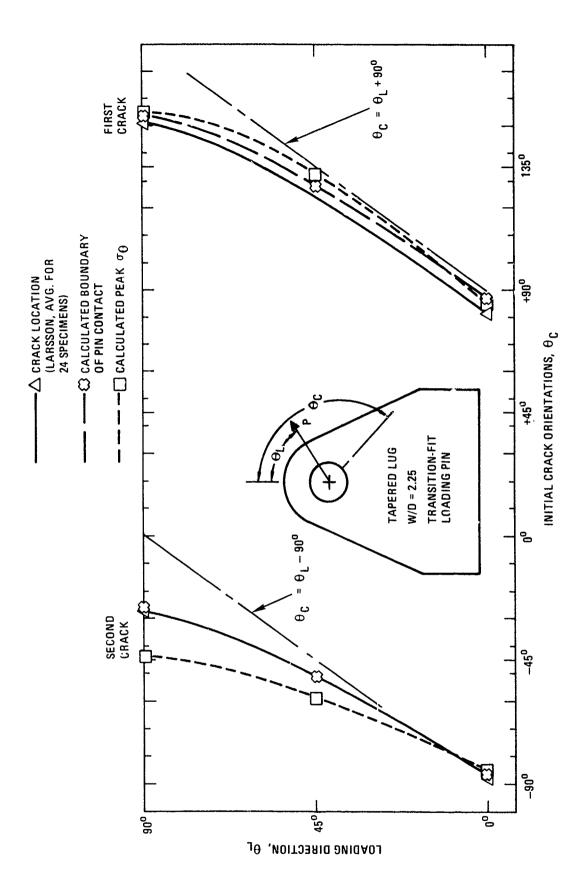
Experimental and Predicted Crack Locations for Various Loading Directions Figure 3-11.

When the pin is a neat-fit pin, the arc of contact is independent of load magnitude, so it doesn't shift during a loading cycle. Thus, for a neat-fit pin, the predicted arc of contact can readily be used to predict the critical location of initial fatigue cracks. Figure 3-11 shows a comparison of predicted and experimental cracking locations in a tapered lug with a neat-fit pin for various loading orientations. The test points are computed averages of data taken from [8]. The predictions of both the boundary of the pin contact arc and the location of peak tangential stress are from finite element analysis results from this program, reported in Volume II of the final report. The locus of points 90 degrees offset from the loading direction is shown for reference.

- Crack location probably coincides with either the maximum tangential tension stress or the location of the edge of the fretting zone of contact. The first crack for loading at  $\theta_L$  = 90 degrees to the lug axis tends to occur at a  $\theta_L$  value of between 150 and 160 degrees from the lug axis; see Figure 3-11. These cracking angles tend to be smaller for clearance-fit pins and larger for interference-fit bushings, and may also be load-magnitude dependent.

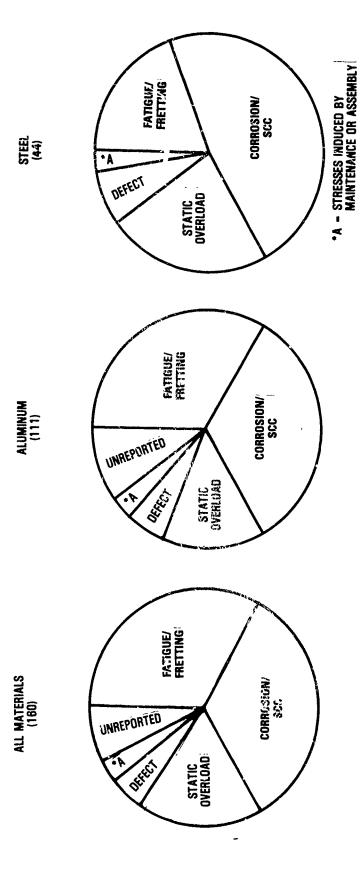
The emphasis being placed upon fatigue testing and analysis in Tasks III through VI of this program must be justified by showing that fatigue crack initiation and growth is a major cause of service failures of lugs. Figures 3-12 and 3-13 show the causes of cracking and causes of failure for the 160 service cracking cases surveyed, and give a breakdown of each for aluminum and steel lugs. The three most common causes of crack initiation and growth were found to be corrosion/stress corrosion cracking (35 percent for initiation and 36 percent for growth), fatigue/fretting (31 percent for initiation and 34 percent for growth), and static overload (21 and 26 percent). In aluminum, fatigue is the major cause of both crack initiation and crack growth, causing 32 percent of initial cracking and 37 percent of crack growth. In steel, corrosion/stress corrosion is the dominant cause of cracking, with fatigue/fretting the cause of crack initiation in 20 percent of cases and fatigue the cause of crack growth in the same percentage.

Figure 3-12. Causes of Initial Cracking of Lugs in Service

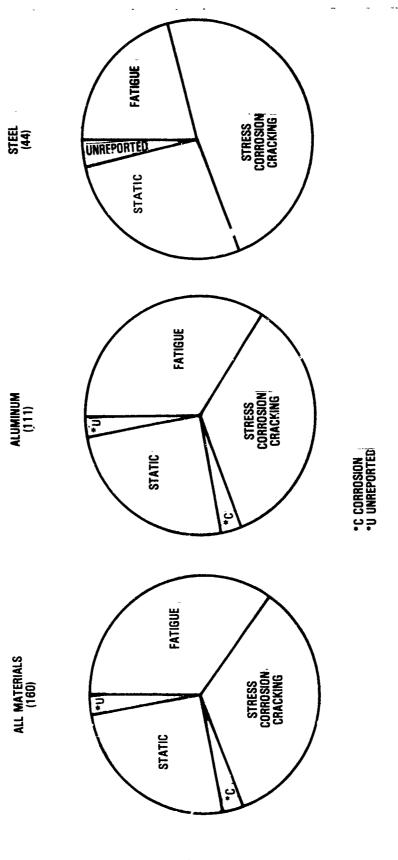
Figure 3-13. Causes of Failure for Lugs in Service

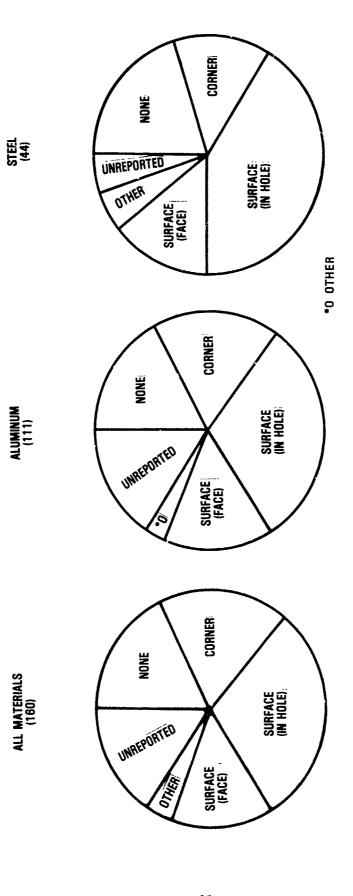
Results of the service cracking data survey indicate that there are three major types of initial cracks common in attachment lugs. As shown in Figure 3-14, the most common is a surface crack in the bore of the hole, which occurs 30 percent of the time in aluminum and 41 percent of the time in steel. One would expect this type of initial crack to evolve into the through-the-thickness crack configuration. The other two most common crack types are a corner crack and a surface crack originating on the specimen face. The surface cracks on the face of the lug often originate near the hole and shortly thereafter become corner cracks.

Figure 3-14. Initial Crack Type

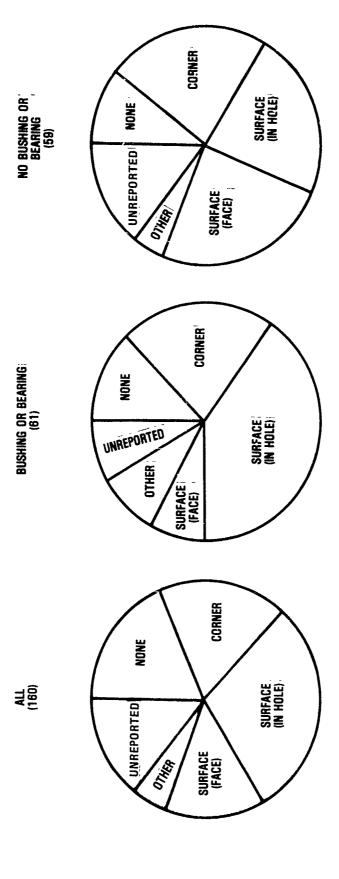
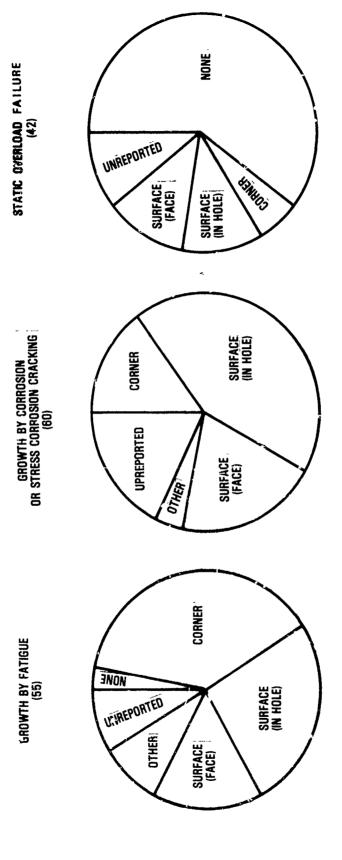
Initial Crack Types Related to the Use of Bushings or Bearings Figure 3-15.

Initial crack types appear to be related to whether or not the lug is fitted with a bushing or bearing. Of the 160 cracking cases, 61 were reported to have bushings or bearings in the lug hole, 59 did not. (No information about bushings or bearings was readily available for the other 40 cases.) As shown in Figure 3-15, lugs with bushings or bearings tended to have surface cracks in the bore of the hole (43 percent) and very few surface cracks on the lug face (eight percent); whereas lugs without bushings had as many surface cracks on the face as in the bore of the hole (25 percent each).

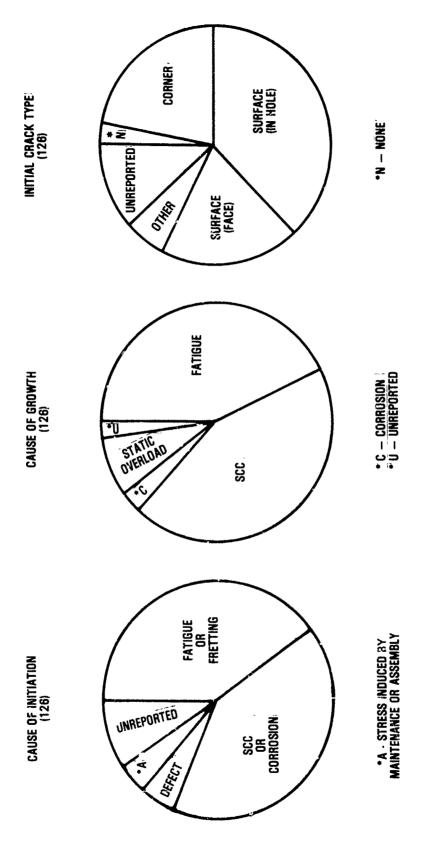
Figure 3-16 shows how the initial crack type relates to the cause of crack growth/failure. Of the cracks grown by fatigue, corner cracks were most common (38 percent), compared to surface cracks in the hole bore (29 percent) and surface cracks on the lug face (15 percent). In contrast, most cracks grown by stress corrosion cracking were initially surface cracks, either in the hole bore (47 percent) or on the lug face (20 percent) rather than corner cracks (12 percent). Furthermore, only five percent of static overload failures were initially corner cracks, while 62 percent were initially uncracked.

Initial Crack Types Related to Cause of Growth/Failure Figure 3-16.

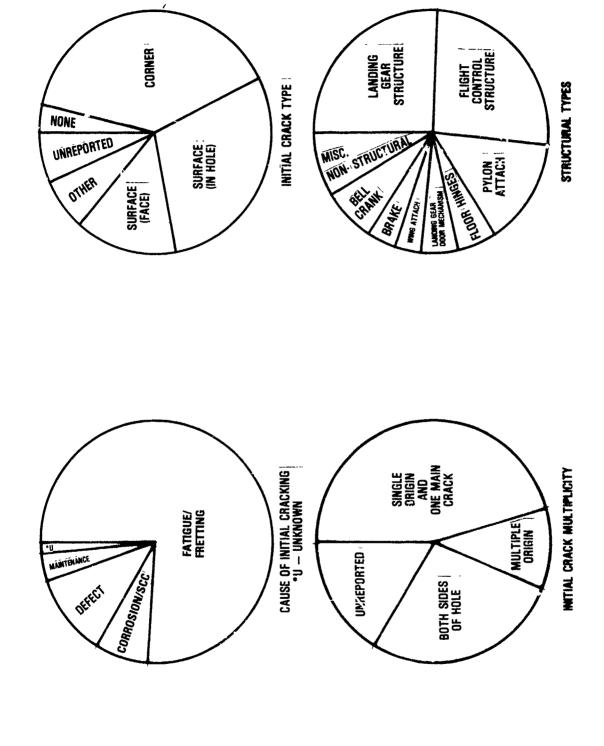
Figure 3-18 provides a closer look at the 55 cases in which service cracks grew by fatigue crack growth. The figure shows that overwhelmingly, these cracks are also initiated by fatigue. As noted earlier, corner cracks and cracks in the bore of the hole are the two most common initial crack geometries. Flaw multiplicity was examined, and multiple crack origins or nearly-equal cracks on both sides of the lug hole were common, occurring almost as often as a single, one-origin crack. The types of structure represented by these 55 fatigue-failed lugs is also summarized in Figure 3-18. Landing gear structure and lugs from flight-control structure (rudder, elevator, spoiler, leading-edge flap, etc.) are the two most common categories. The survey also included pylon or engine-attach structure, floor hinges on cargo aircraft, landing gear door hinges, wing attach fittings, brake fittings, some bell cranks of undefined function, and a few lugs which may have been non-structural.

Results for 55 Lugs that Failed in Service by Fatigue Crack Growth. Figure 3-18.

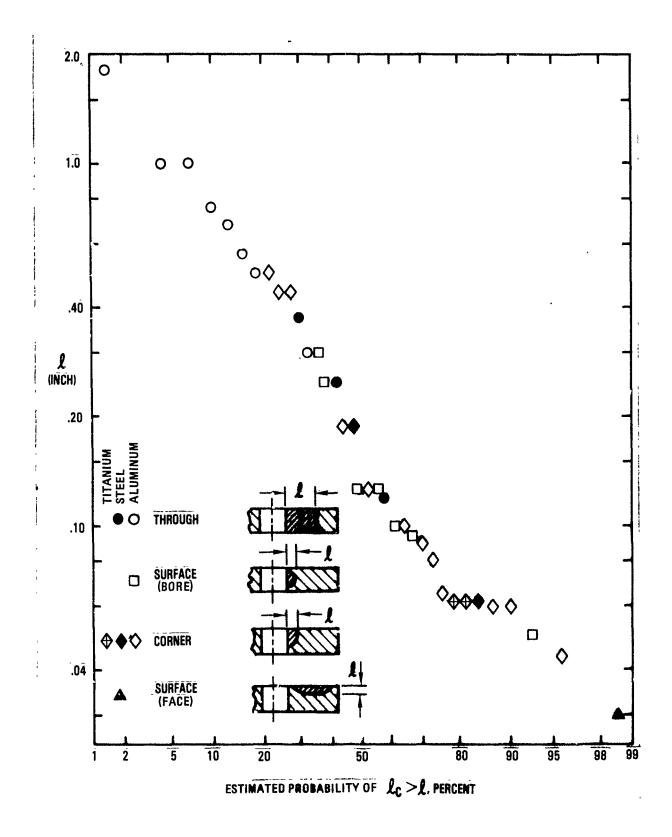
If lugs are to be designed for damage tolerance it must be possible to discover the cracks before they reach critical size. A goal is to maximize the difference between the critical crack size and the initial discoverable size. The initial size depends on NDI capability as described in Section 4. Enough information was available from 35 of the fatigue crack growth failure cases to obtain reasonable estimates of critical crack size. The probability plot shown in Figure 3-19 indicates a median critical crack size of  $\ell$  = 0.125-inch. (The definition of  $\ell$  varies depending upon the type of crack, as defined in Figure 3-19.)

A goal of new damage tolerance requirements for lugs would be to eliminate all or nearly all of the service failures represented in Figure 3-19. The types of failures resulting from small critical crack sizes can probably be regarded as design problems, requiring lower stresses or load redundancy to achieve a design that is truly damage tolerant. Those with longer critical cracks can most likely be regarded as inspection problems, requiring more frequent or more reliable NDI.

Figure 3-19. Critical Crack Sizes after Fatigue Crack Growth in 35 Service Failed Lugs (Air Force ALC Data Only)

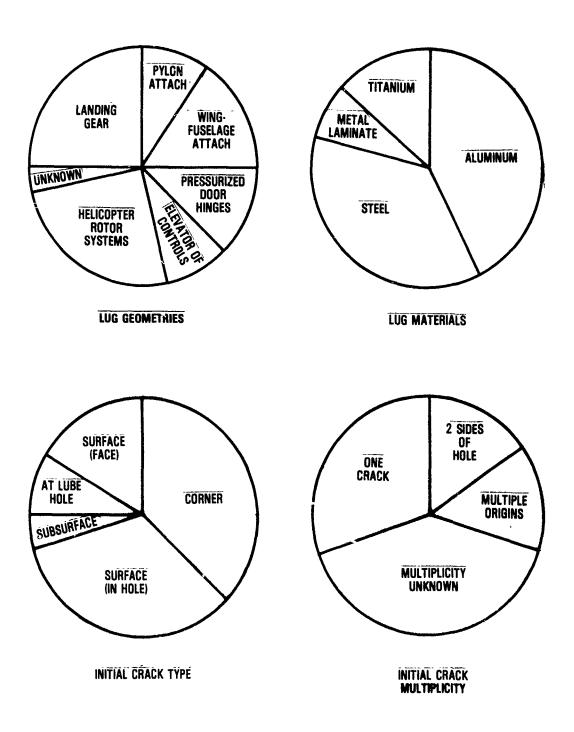
Nevertheless, 24 full-scale test results were found for the survey. The results are summarized in Figure 3-20. A good cross section of critical structural applications was represented, including two pylon attachment lugs, four wing-fuselage attachment lugs, six landing gear lugs and six helicopter rotor system lugs. Corner and surface cracks in the bore of the hole were the most common types of cracks found, as in the case of the service cracking fatigue data. Of the 14 cases where multiple cracking information was adequately reported, single and multiple cracking was equally likely, which also was similar to the crack multiplicity data from service fatigue failures shown in Figure 3-18.

Figure 3-20. Cracking Data Results from 24 Full-Scale Fatigue Test Failures of Lugs
